Date: 08/14/2008

RE: Inspection of [REDACTED] Columbia, SC 29212

Summary List

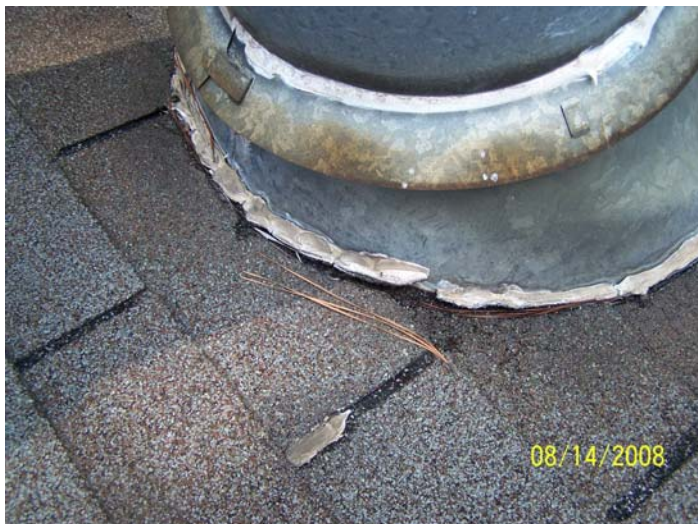
1. The exterior of the metal chimney is in serviceable condition but recommend that the caulking on the flashing be replaced as it is cracked and missing in places.

Replace caulking on chimney flashing

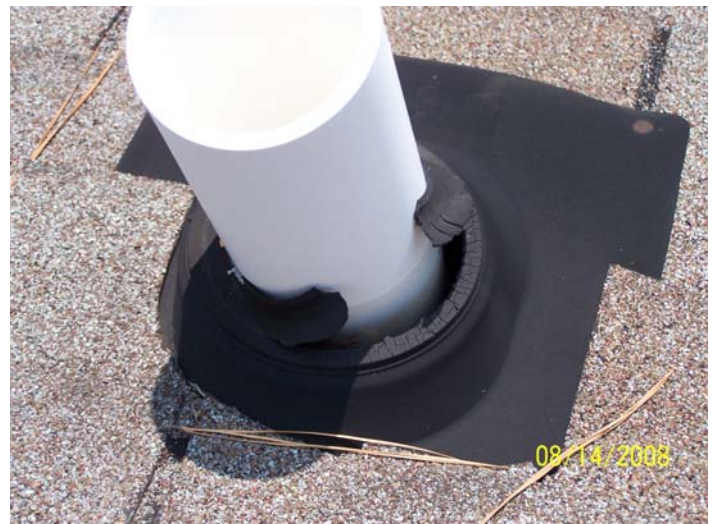
3. The three plumbing vent pipes are in serviceable condition but the boots (flashing) around them are cracked and have voids and must be replaced. There was no obvious water intrusion but some water has to be getting into the attic area down the outside of the piping.

Replace vent boots on all three plumbing vents

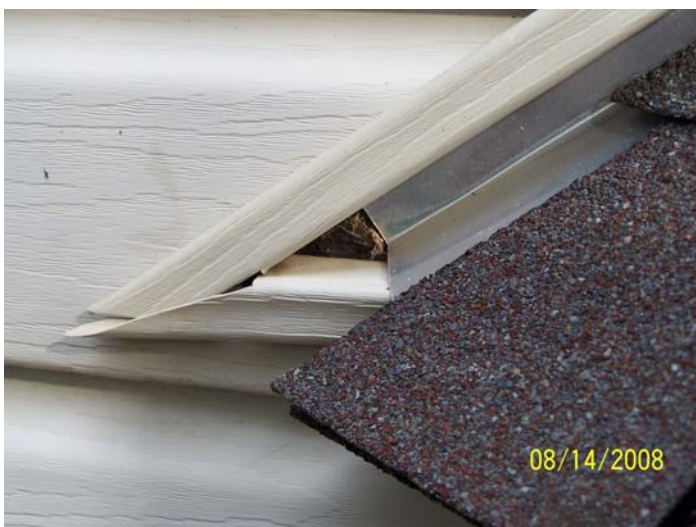
4. There is a small section of step flashing missing at the of the porch roof near the rear entry door.
5. There is an area of the siding on the right side that is not properly secured and should be snapped back into place and secured.

Seal or add flashing to keep water out

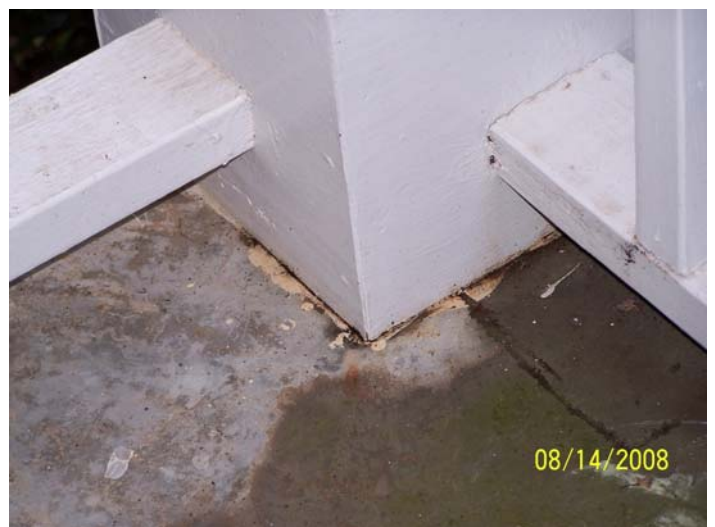
11. Recommend sealing at the bottom of the front porch supporting post where they are touching the concrete porch deck.
12. The front porch has no railings and is a safety concern. There are a few areas where there are voids in the concrete that should be repaired to avoid future problems.

Seal at bottom of front porch posts

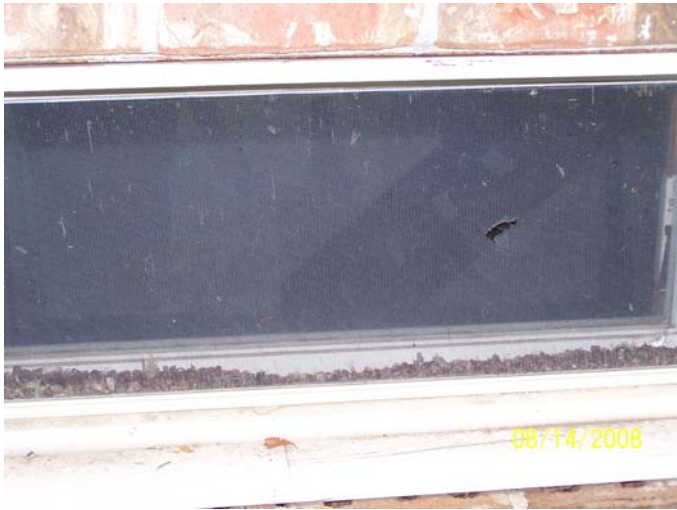
19. The basement windows on the right side need to be cleaned of debris and the exterior trim sealed.
20. There was some evidence of dampness on the front basement wall. Along with trying to keep water away on the outside, recommend sealing the inside wall with some type of water sealing paint.

Basement window – Clean and caulk

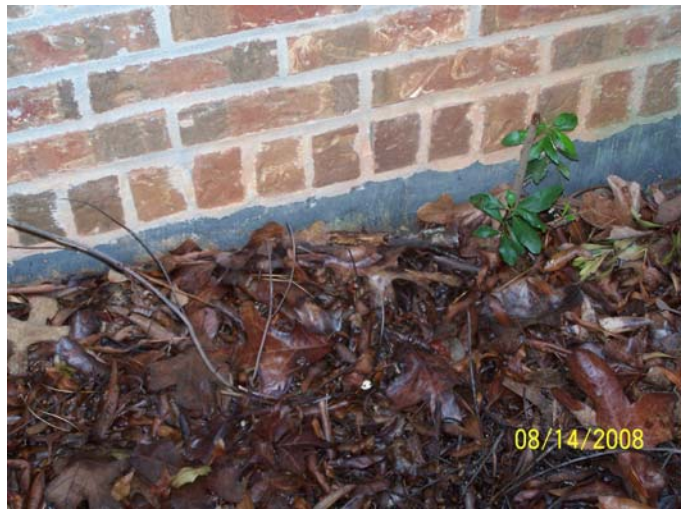
17. The rear exterior outlet by the entry door on the screened porch is not properly secured. Repair.
18. The yard drainage and the grading at the foundation are a concern and must be monitored and addressed as necessary. The biggest concerns are the front and left side. There is an eroded area at the left rear corner of the home. This should be filled (possibly with concrete) and the reason for it should be determined. It may have started with the dogs digging but there also appears to be a water source for the erosion. Build up grading at the foundation walls to direct water away and as necessary create swales to direct water around and away from the home.

Grading at foundation. Increase and remove debris

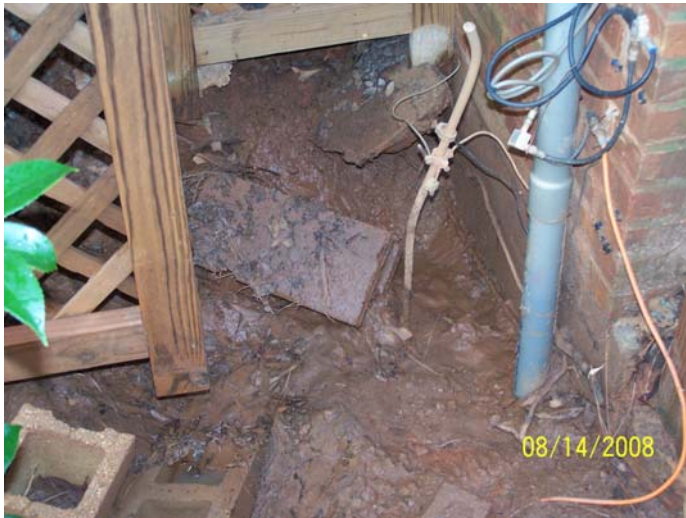
Eroded area in left rear

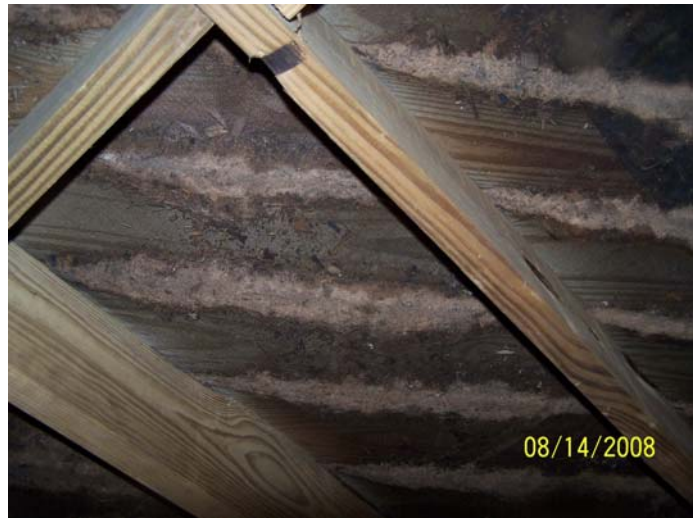
13. The rear porch has netting under the deck boards which serves to catch debris and potentially keep the bottom of the deck boards wet. Recommend removing the netting to keep water from being held under the boards.

Netting under screened porch. Retains water

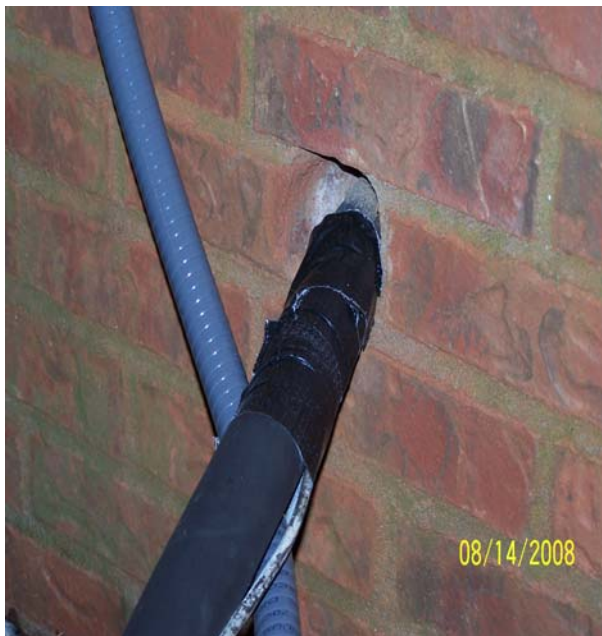
27. Add sealant around the HP coolant lines foundation entry hole.
28. The air filters for the heating system need to be changed immediately and on a regular basis.

Seal hole around coolant lines

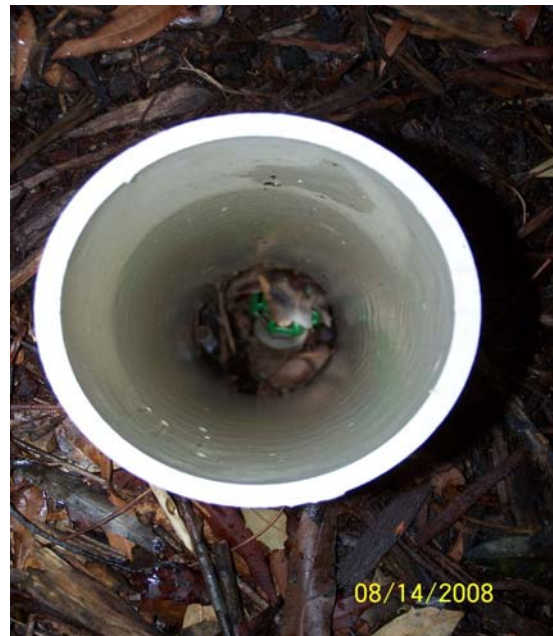
Main water shutoff

6. The kitchen has no GFCI receptacles. Recommend adding them at least near the sink.
7. Did not test smoke detectors due to the security system. Recommend a smoke detector in each bedroom, outside the bedroom areas and on each floor.
8. The second floor guest bath GFCI receptacle protects the exterior receptacle, and all the other bath receptacles.
9. Heat Pump Payne Model PH3ANA036-C. Serial #1108E10211. New this year. Located in rear under deck. 3 ton unit. Air handler also new.
10. Recommend adding metal braided hoses for the water line connections to the washer.
11. The main water shutoff is located in the left front of the home but it is very deep and would not be easily reached.
