Playing it Safe Home Inspection Report

Walter G. Henegar
Playing it Safe Home Inspection P.C.
RHI License # 437
568 Rapids Rd.
Columbia, S.C. 29212
803-445-4411

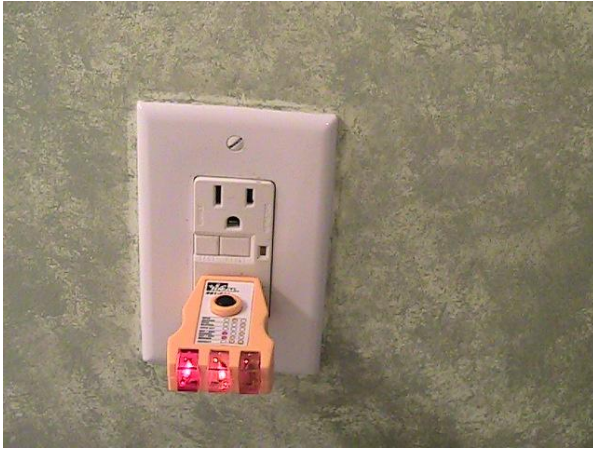
- **Repair:** *The ground fault circuit interrupter (GFCI) in the master bathroom did not respond properly to testing. It should be repaired. The hot and neutral tested reverse polarity.*

1. The ground fault circuit interrupter (GFCI) in the master bathroom did not respond properly to testing. It should be repaired. The hot and neutral tested reverse polarity.

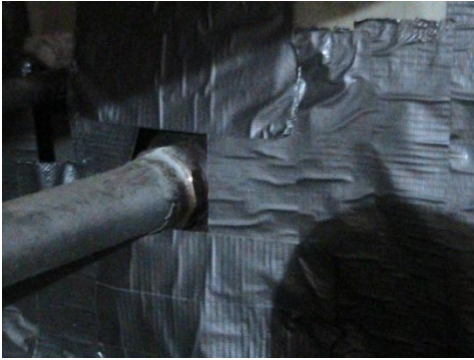
13. The wall inside the master bathroom vanity cabinet was tapped up around the pipe. This may have had past repairs made to the sink, however no signs of leaks at the time of inspection.

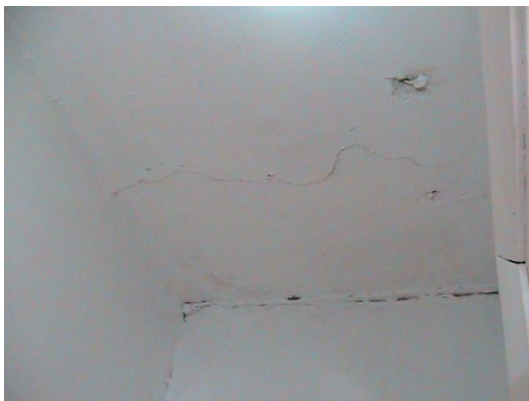
- 14. Past repaired damaged ceiling noted in the master bedroom back closet on the ceiling. This appears to be past damage. Recommend monitoring.*

8. Past repaired damaged ceiling noted in the master bedroom back closet on the ceiling. This appears to be past damage. Recommend monitoring.

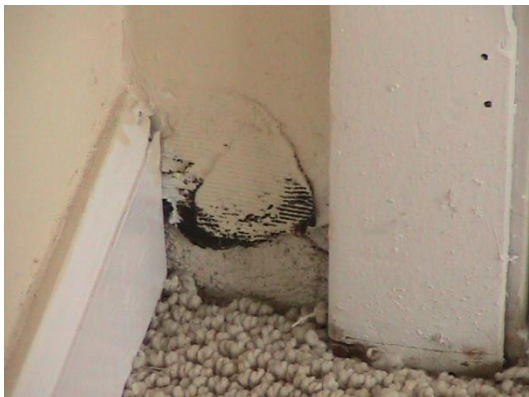
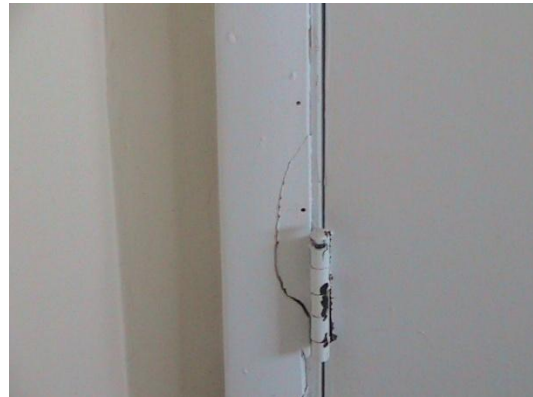
- 15. Split trim on door casing moldings behind master bedroom door. Also missing base moldings behind door.*

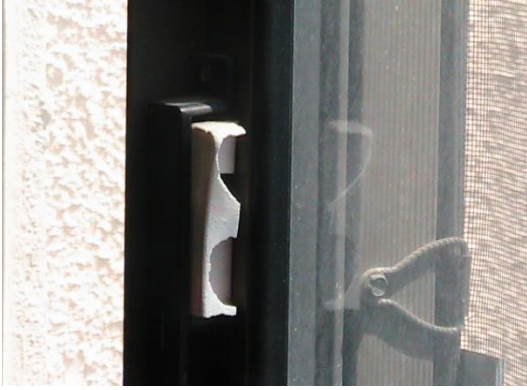
- 16. Damage window handles noted on both bedroom windows. Repair as needed.*

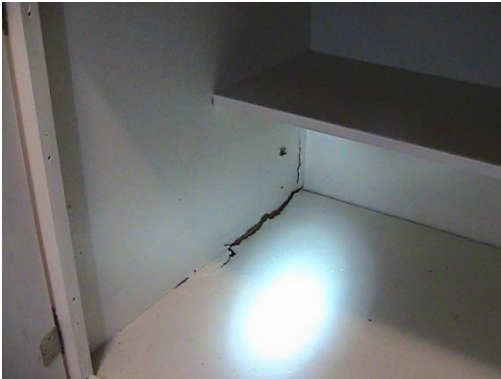
17. *Under the kitchen cabinet showed damage to the inside cabinet next to the refrigerator. Base board appears to have been pushed down. This does not appear to be very strong material used.*

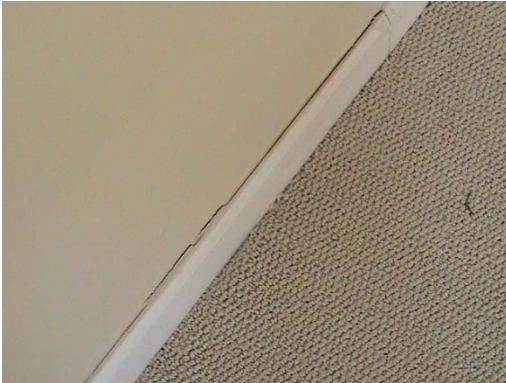
18. *Recommend re-caulking some of the interior base moulding where there were separation noted.*

9. Recommend re-caulking some of the interior base moulding where there were separation noted.
